Concrete Restoration

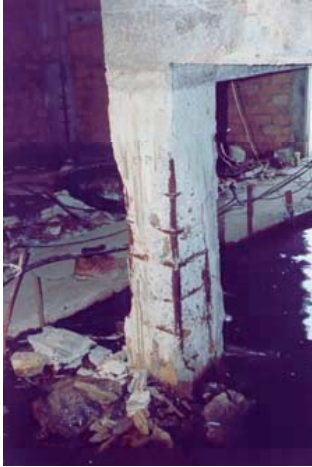
Corroded reinforcement behind spalling concrete
